Nuclear Safety

Update on Fukushima Dai-ichi Nuclear Accident and IAEA response

Nuclear Installation Safety
Department of Nuclear Safety & Security

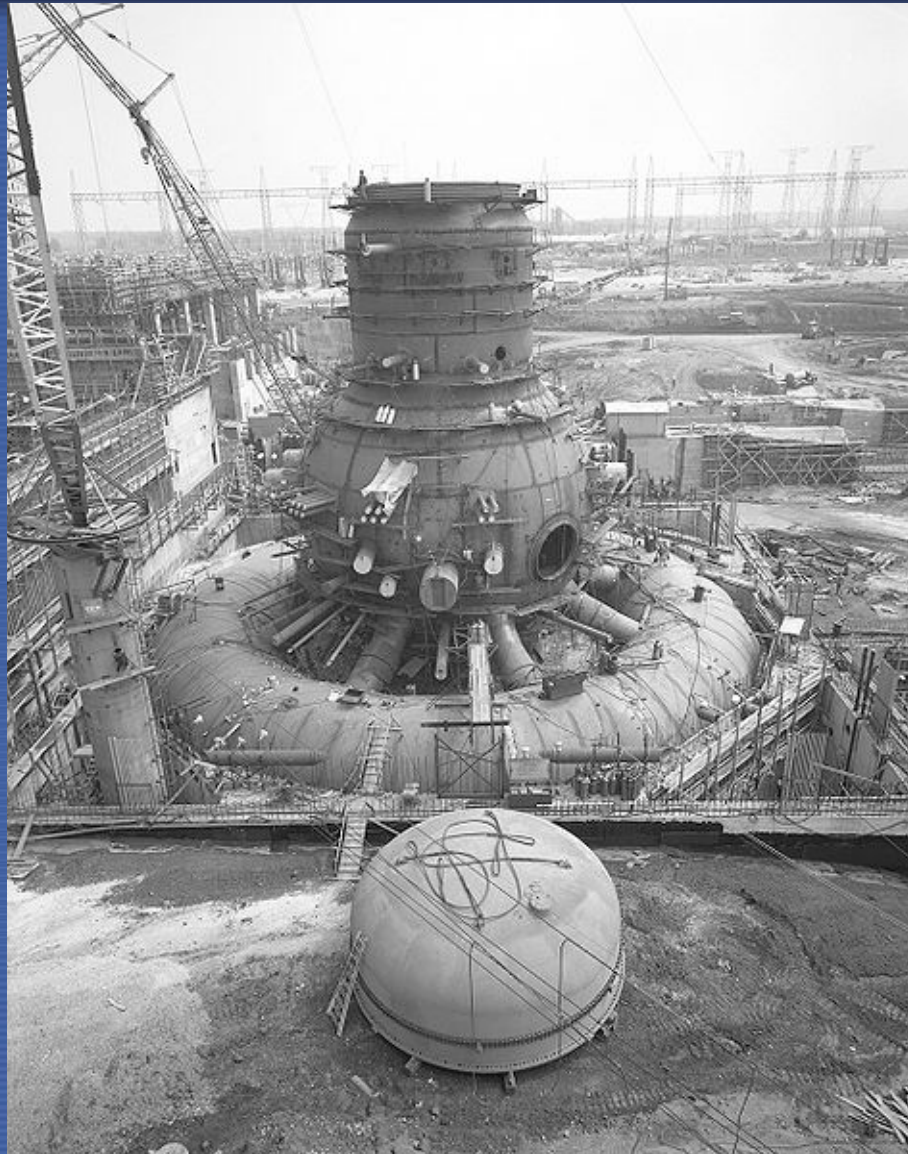
BWR Mark I Primary Containment Vessel and Torus
